**Flood Control Project Maintenance  
Levee Inspections**

## Maintenance Issue Types Only, Levee Inspection Report By Mile - Fall 2015

### Sutter Maintenance Yard Nelson Bend

Waterway	Bank	Unit Miles	Inspection Start/End	Inspector
Unit No. 01 Feather River West Levee - Nelson Bend		0.50	11/18/2015 11/18/2015	Bob Duffey

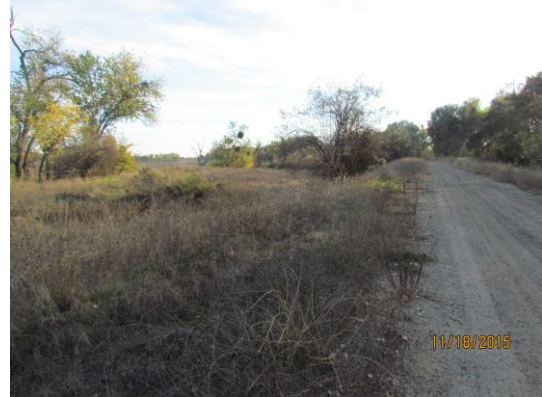
Photo 1 of 1 : FA\_2015\_ST0006\_471\_15\_20151120\_00005.jpg

LM Start	0.02	Rating **	U	Issue No.	15
LM End	0.42	Issue Type +	Ma	Location *	WS
Category	Earthen Levee			GPS Latitude/Longitude	
				Start	End
Item	Vegetation			38.886883 °	38.881287 °
				-121.614797 °	-121.614490 °
DWR ID	DWR_ST0006_01_f_2015_15				
Action/Comments					
Remove the wild growth other than native grasses from the levee slopes. Inspector Comments: Remove the vegetation and trim up the trees 5 feet for visibility.

View of the trees, vegetation and elderberries along the waterside slope.

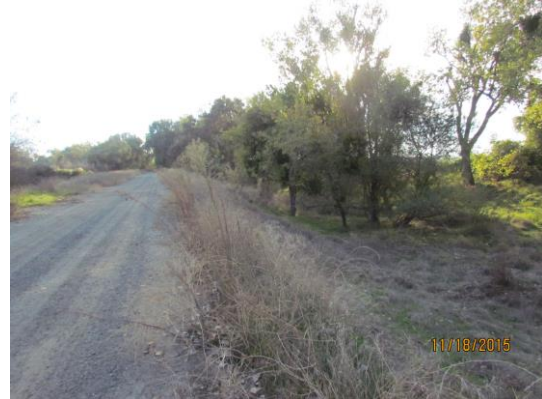
Photo 1 of 1 : FA\_2015\_ST0006\_471\_2\_20151120\_00006.jpg

LM Start	0.02	Rating **	U	Issue No.	2
LM End	0.46	Issue Type +	Ma	Location *	LS
Category	Earthen Levee			GPS Latitude/Longitude	
				Start	End
Item	Vegetation			38.886883 °	38.880833 °
				-121.614797 °	-121.614387 °
DWR ID	DWR_ST0006_01_f_2015_2				
Action/Comments					
Remove the wild growth other than native grasses from the levee slopes.					
Inspector Comments: Remove the vegetation and trim up the trees 5 feet for visibility.

View of the vegetation, trees and elderberries along the landside slope.

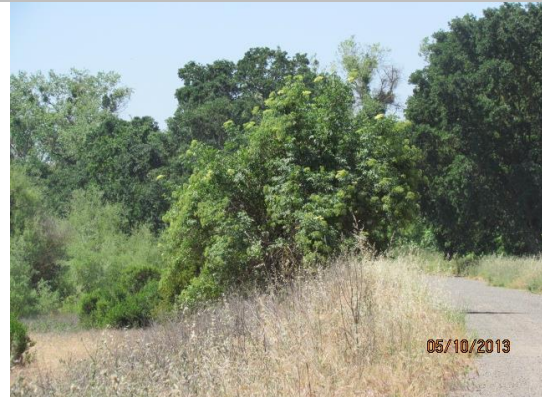
Photo 1 of 1 : FA\_2015\_ST0006\_471\_4\_20151109\_00003.jpg

LM Start	0.06	Rating **	M	Issue No.	4
LM End	0.06	Issue Type +	Ma	Location *	WS
Category	Earthen Levee			GPS Latitude/Longitude	
				Start	End
Item	Vegetation			38.886277 °	38.886277 °
				-121.615129 °	-121.615129 °
DWR ID	DWR_ST0006_01_s_2012_4				
Action/Comments					
Elderberries are blocking visibility and flood fight capability. Inspector Comments: Elderberries are partially blocking visibility.

View of the elderberries that are blocking visibility.
